NATURE AND CAUSE OF DECAY

IN BUILDING TIMBERS

By C. J. HUMPHREY

Presented
April, 1923

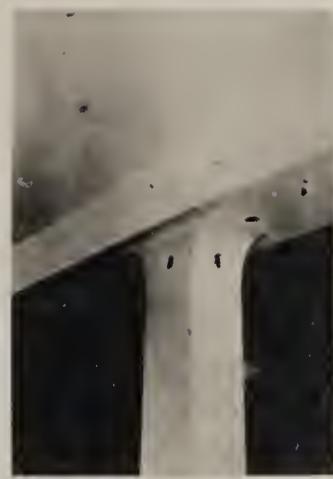
4

In a semi-mill constructed building in Chicago investigated several years ago¹, the partially seasoned low-grade pine timbers had been fully enclosed with plaster board (fig. 4) while in a moist condition. In approximately two years the floors began to sag and a few of the girders and posts in the basement failed (fig. 5). A thorough examination then indicated the necessity of extensive repairs throughout the six stories of the structure as a direct result of decay in the undried structural members.

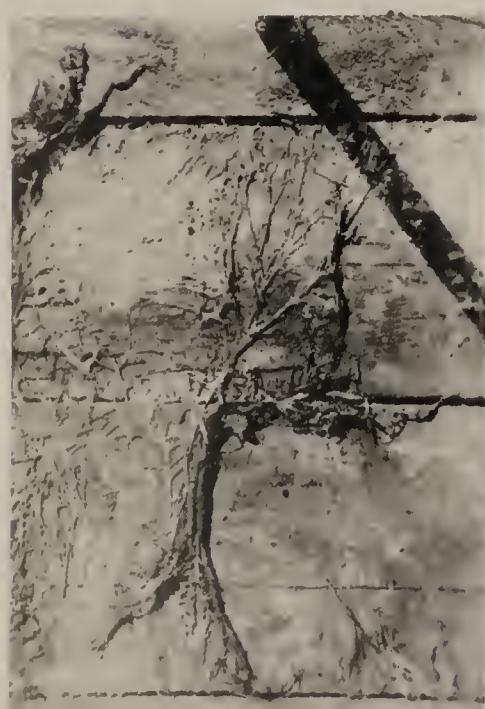
6

Figure 6.--The water conducting strands (rhizomorphs) of dry rot fungi, belonging to the Merulius group much resemble cords or roots. The ones shown here are growing between the layers of lumber in a pile stored in a New England lumber yard. The growth occurred near the base of the pile and was exposed when the upper layers of stock were removed.

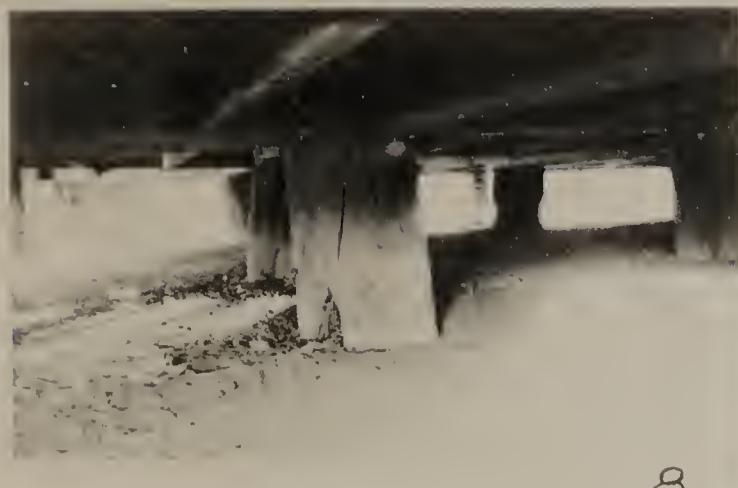
8

The dry rot fungi are all rapid growers and seem to be prevalent in soil in the moister parts of the country. It is therefore highly unsafe, practically an invitation to disaster, to allow any cellar, foundation (fig. 8) or first floor timbers (fig. 9 and 10) to come in contact with the soil, or very close to it, unless they have been thoroughly impregnated with a wood preservative.

1. Foundation or basement timber should never be placed in contact with the soil, unless the timber is impregnated with an antiseptic.

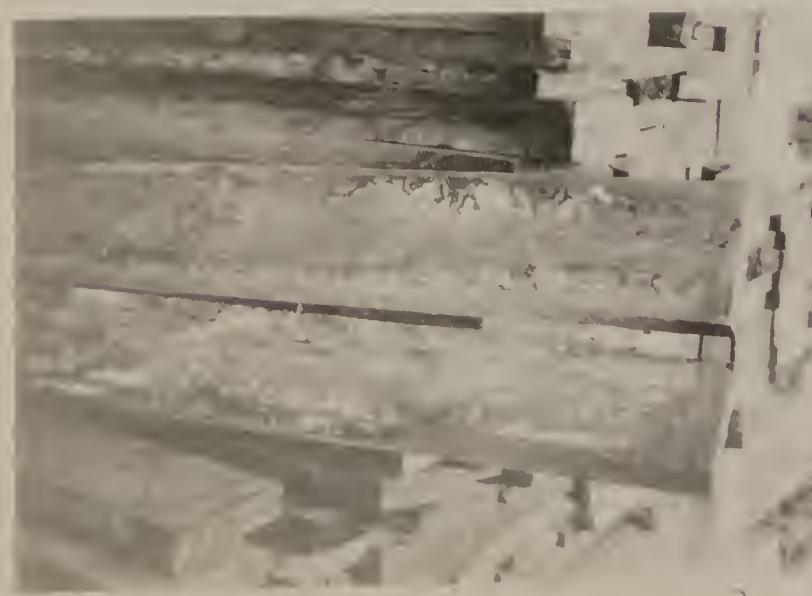
12

Figure 12.--Dry rot infections in stored lumber are altogether too common. They constitute a hazard to the building interests which should not be tolerated. An infected timber may soon develop into a rapid growing cancerous scourge when introduced into a building.

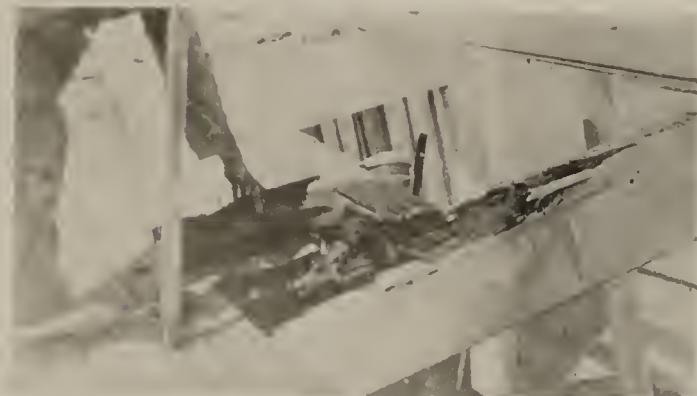
17

The principal decay in the roofs often occurs in the outer half or within a more or less middle plane in the 3 to 4-inch planks (fig. 16), and over the beams, at which point the rot at the contacts is severe (fig. 17). This localization of rot can perhaps be best explained by assuming a definite set of conditions in illustration. Suppose the outside air to be at 30° , the room temperature 70° , and the dew point 60° , with very little air circulation under the roof. Whenever the interior air next to the under surface cools to 60° or less, condensation (sweating) takes place and saturates the lower surface of the planks, gradually being absorbed toward the center. Fungous growth then becomes conditioned by both moisture and temperature within the piece. If lower temperatures and drier wood tend to retard rapid development on the upper face and the lower face becomes too wet to decay, rotting will take place in the interior. If the lower face does not become too wet it will also decay.

Rot in the planks can be prevented by increasing the insulation of the roof and by a suitable distribution of the heating pipes so as to prevent moist air from condensing on the under surface. For new construction, a double roof consisting of an inner layer of durable untreated timber of a good grade and an outer layer of creosoted stock with a triple layer of mopped tarred roofing between, will be found satisfactory; the whole to be tarred and graveled in the usual manner.
